TECHNICAL NOTE 2538

MECHANICAL AND CORROSION TESTS OF SPOT-WELDED
ALUMINUM ALLOYS

MECHANICAL AND CORROSION TESTS OF SPOT-WELDED

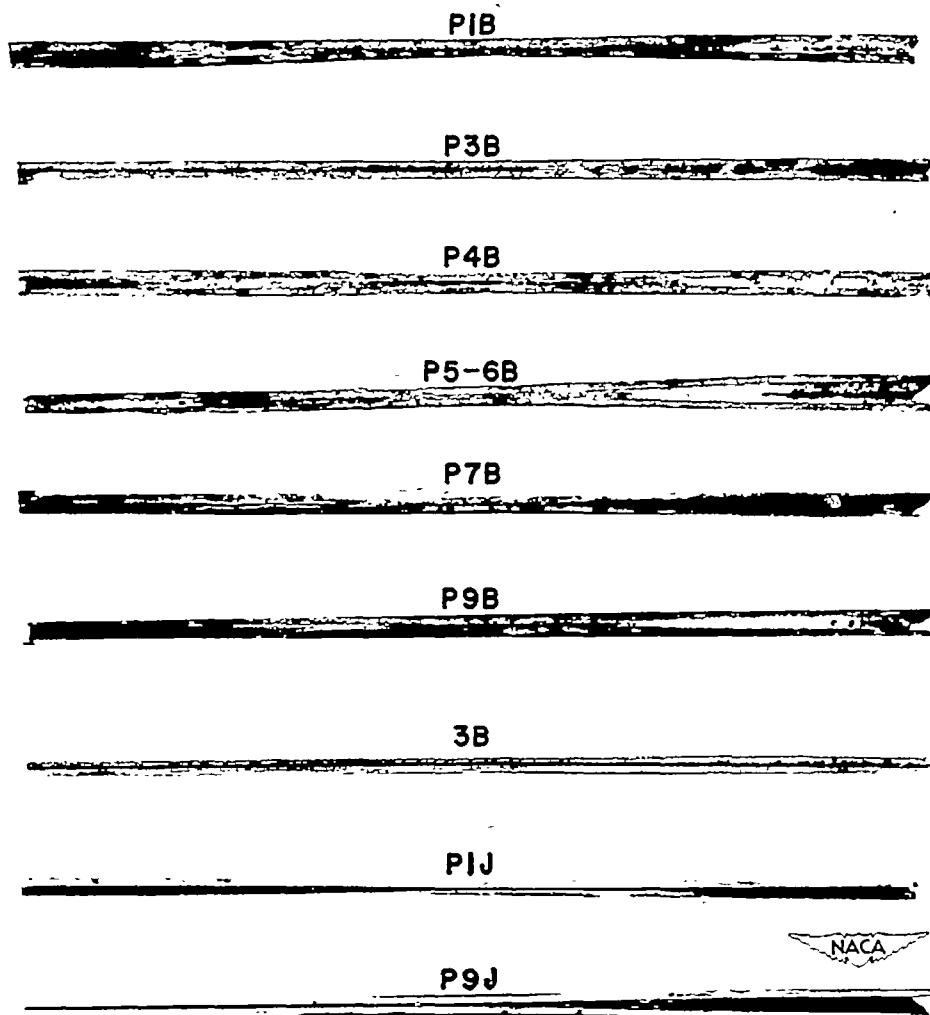
- 1 corrosion products between faying surfaces forced sheets apart a maximum distance of $1/16$ inch (Illustrations of separations of faying surfaces are shown in figs. 15 and 16.)
- 2 corrosion products between faying surfaces forced sheets apart a distance of $2/16$ inch
- 3 corrosion products between faying surfaces forced sheets apart a distance of $3/16$ inch

Figure 15.- Separation of sheets resulting from accumulation of corrosion products between faying surfaces, XI. Exposed in tidewater for 6 months. Panel 3B, alclad 24S-T3, was inserted for comparison purposes; no accumulation of corrosion products at faying surfaces.

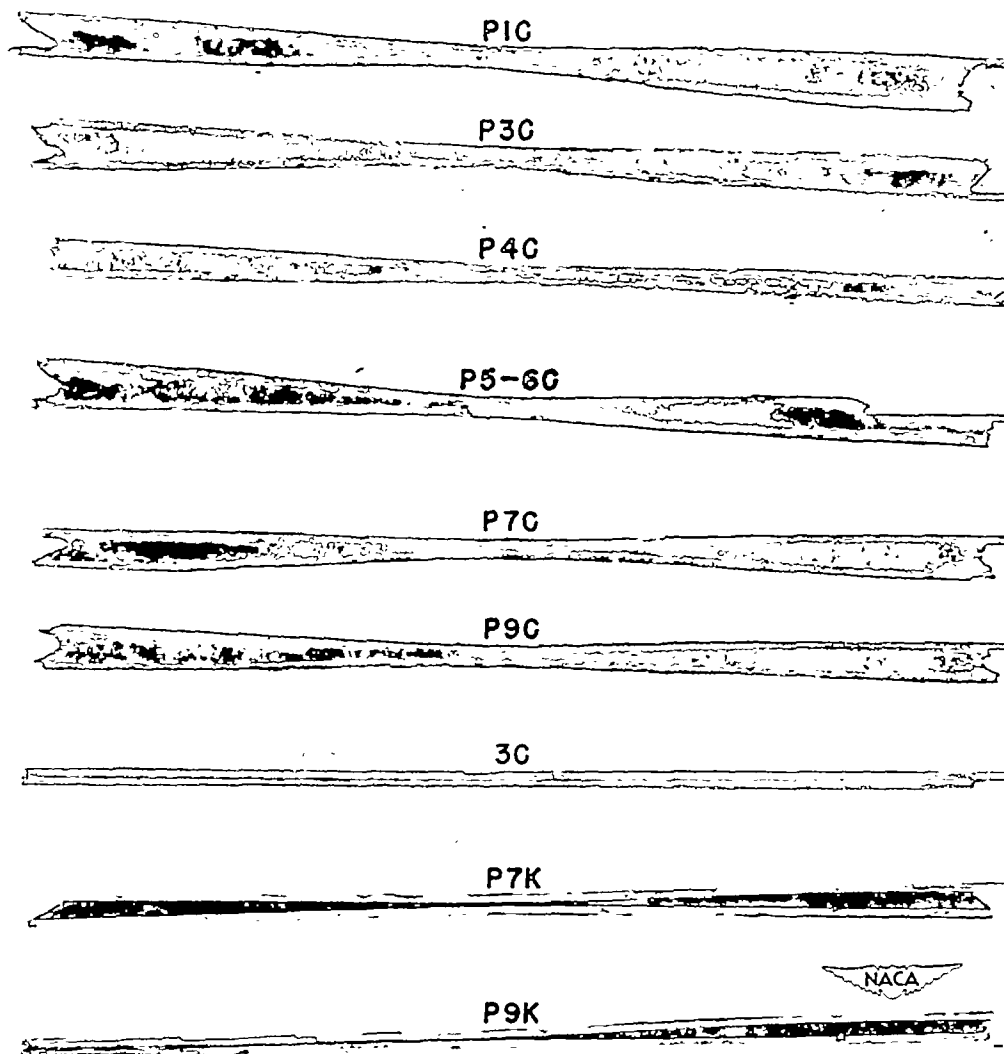
Figure 16.- Separation of sheets resulting from accumulation of corrosion products between faying surfaces, XI. Exposed in tidewater for 12 months. Panel 3C, alclad 24S-T3, was inserted for comparison purposes; no accumulation of corrosion products at faying surfaces.

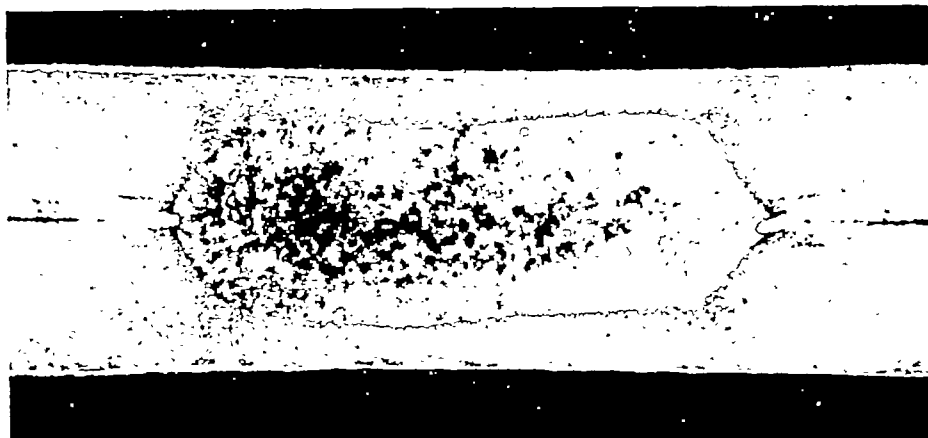
Figure 18.- Macrostructure of weld zone of sample 1C, alclad 24S-T3, exposed to tidewater for 1 year, X20. Keller's etch, 20 seconds. Weld structure was sound and uniformly distributed between two sheets. Structure was characteristic of group 1 samples which were welded under conditions to produce sound welds after chemical preparation of sheet surfaces.

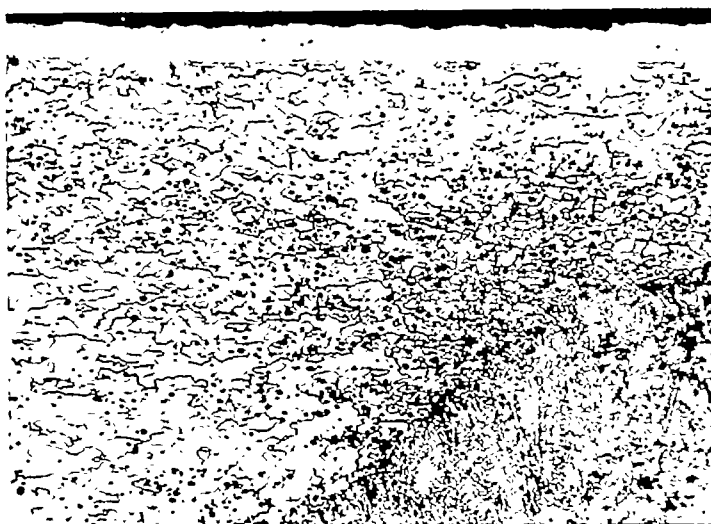
Figure 19.- Area from upper left corner of nugget shown in figure 18, X100. Keller's etch, 20 seconds. No significant extent of corrosion attack was observed on this sample.

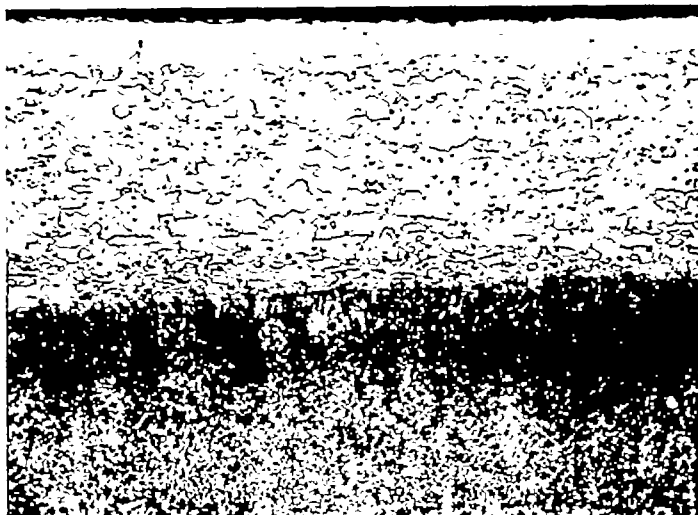
Figure 20.- Typical appearance of portion of nugget, core, and clad regions in sample 1G, alclad 24S-T3 sheet, exposed 3 years to laboratory atmosphere, X100. Keller's etch, 20 seconds. No evidence of corrosion attack on this sample.

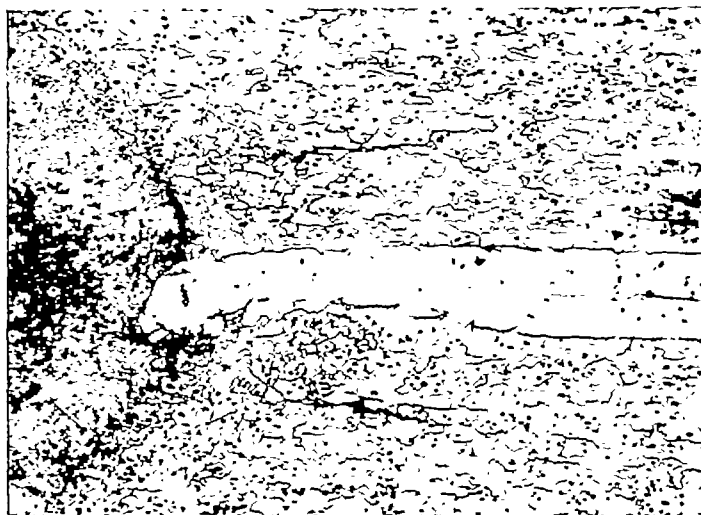
Figure 21.- Nugget-faying surface interface of sample shown in figure 20, X100. Keller's etch, 20 seconds. Structure was typical of appearance of alclad 24S-T3 samples examined in this study. Note continuation of higher-melting 2S clad into nugget zone and intrusion of eutectic into core structure above and below cladding.

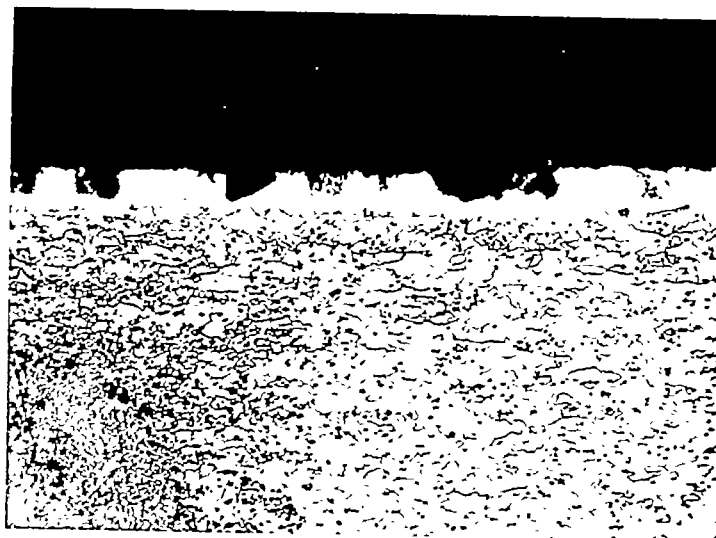
Figure 22.- Most severe degree of pitting type of corrosion attack on sample 1E, alclad 24S-T3, exposed 3 years to a sea coast atmosphere, X100. Keller's etch, 20 seconds. Attack was concentrated near weld zone and did not penetrate cladding.

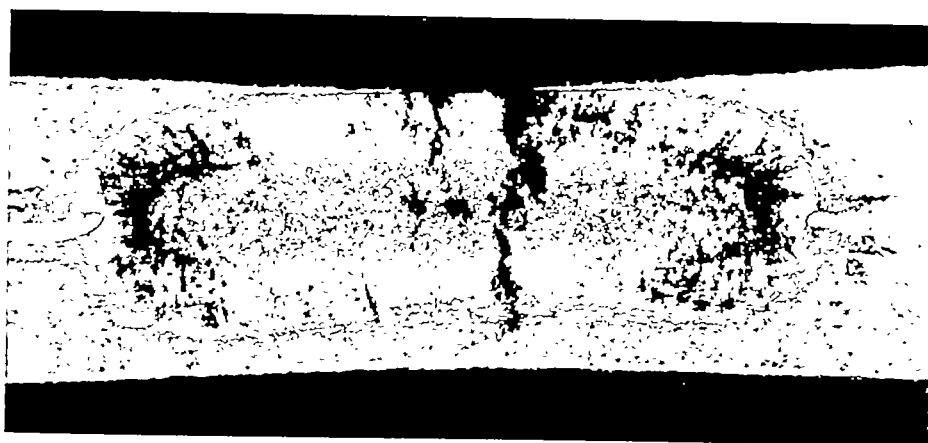
Figure 23.- Macrostructure of sample 5C, alclad 24S-T3, welded under conditions to produce cracking to surface and exposed 1 year to tidewater, X20. Keller's etch, 20 seconds. Nugget has absorbed portion of cladding on one surface. See figure 24.

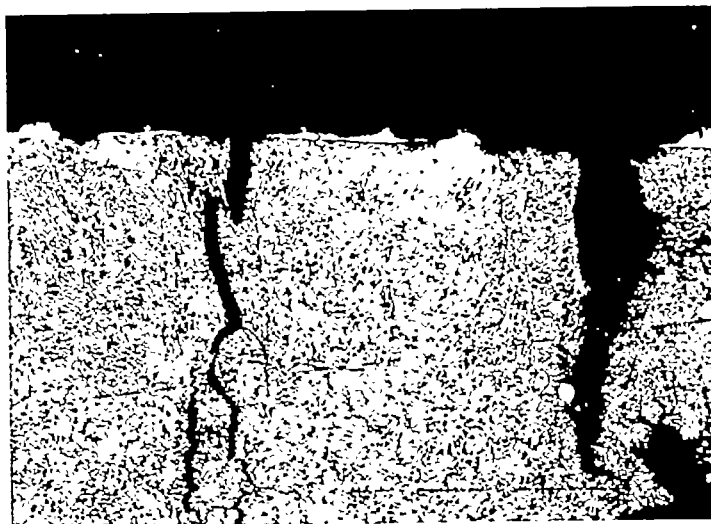
Figure 24.- Area from the top-center surface of weld shown in figure 23, X100. Keller's etch, 20 seconds. Note that tiny fragments of cladding have remained to provide effective cathodic protection for underlying core.

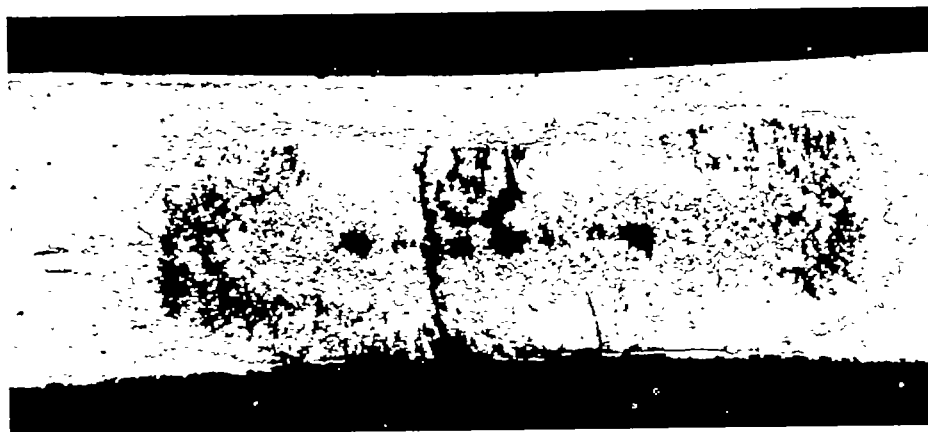
Figure 25.- Macrostructure of sample 5F, alclad 24S-T3, exposed 3 years to sea coast atmosphere after welding to produce cracks to surface, X20. Keller's etch, 20 seconds. Compare with figure 23. Note corrosion attack in cladding in vicinity of weld along bottom.

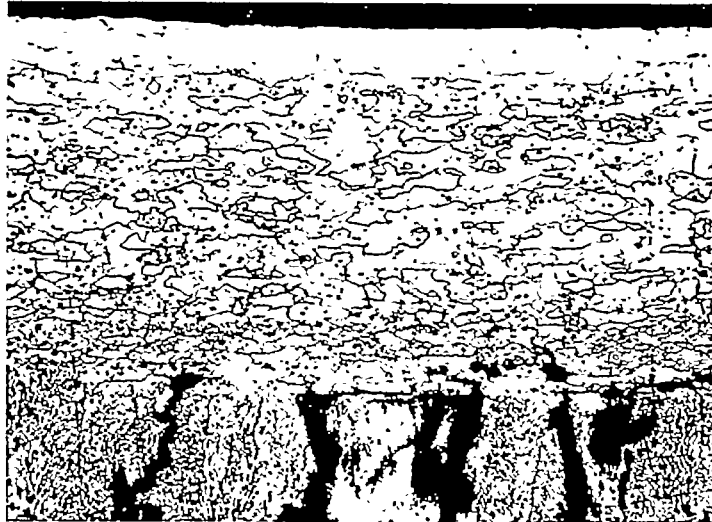
Figure 26.- Area from top center of figure 25 showing no significant extent of corrosion attack on surface, X100. Keller's etch, 20 seconds. Lower side of weld in figure 25 was similar in appearance to figure 24.

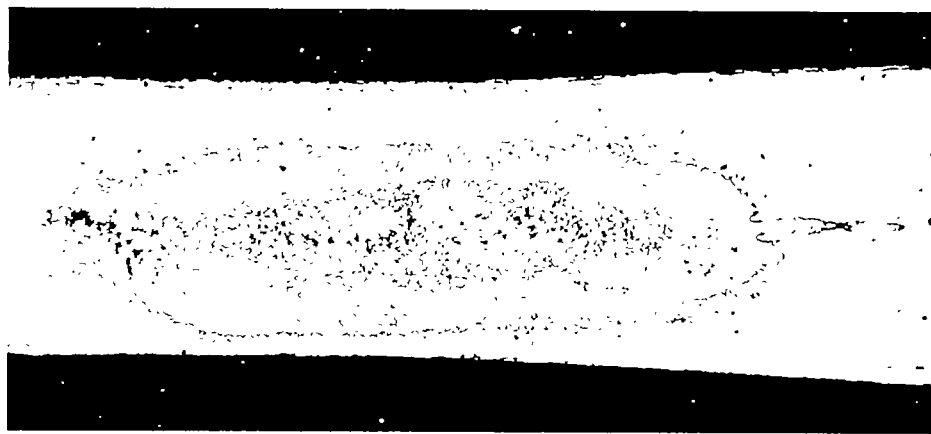
Figure 27.- Example of expulsion between faying surfaces of sample 6C, alclad 24S-T3, welded under conditions to induce expulsion and exposed 1 year to tidewater, X20. Keller's etch, 20 seconds.

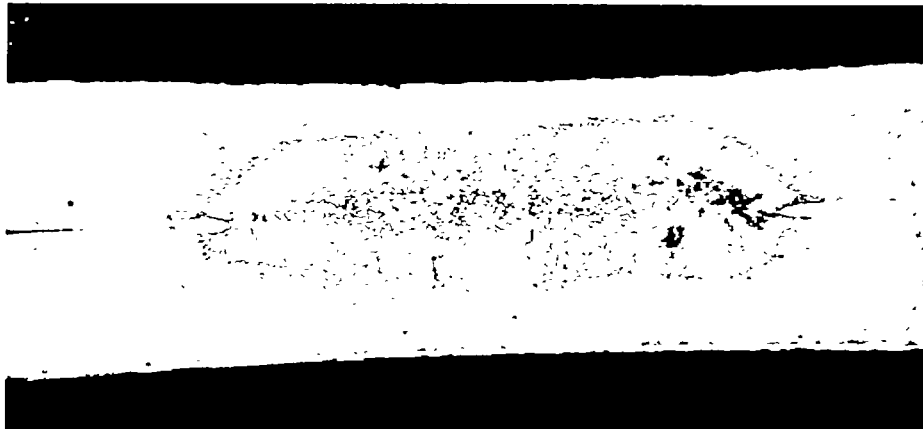
Figure 29.- Macrostructure of sample 6F, alclad 24S-T3, welded under conditions to produce expulsion and exposed 3 years in sea coast weather, X20. Keller's etch, 20 seconds.

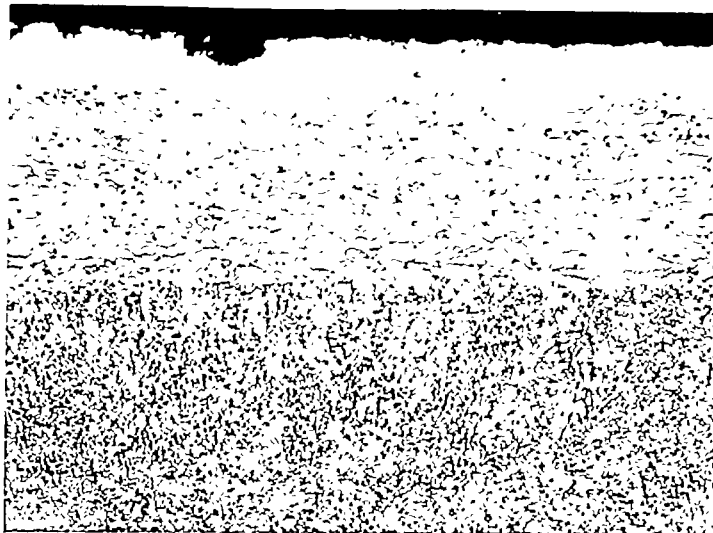
Figure 30.- Most severe degree of corrosion attack found in this specimen did not penetrate cladding. Area is from top center of figure 29, X100. Keller's etch, 20 seconds. No significant extent of attack on sheet away from weld zone. Note fine cracks in lower left corner in nugget structure.

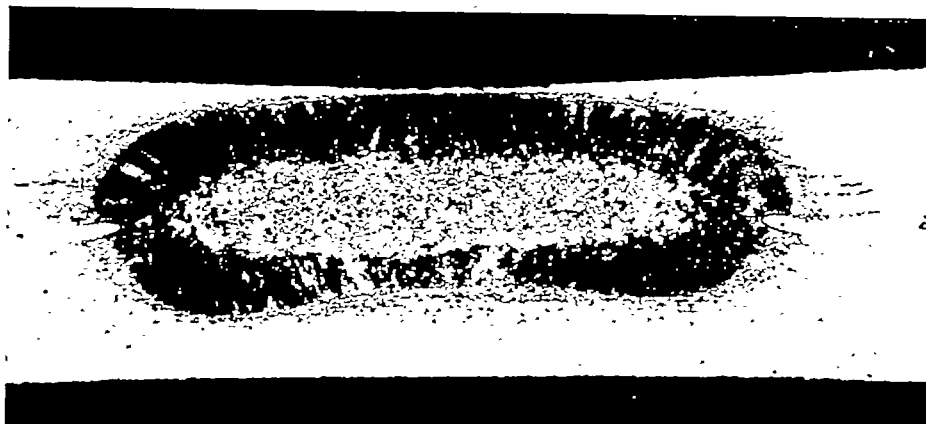
Figure 31.- Sample 9C, alclad 24S-T3, welded under conditions to produce a sound weld after wire-brush preparation. Nugget penetrated entirely to the cladding, X20. Keller's etch, 20 seconds.

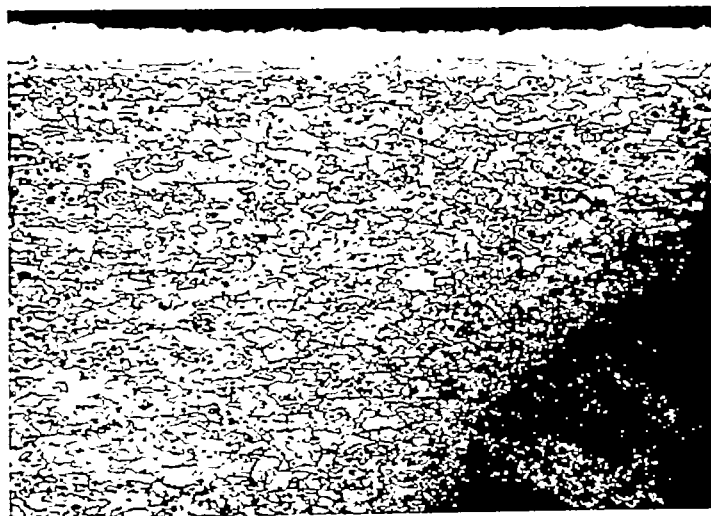
Figure 33.- General condition of diffusion of copper into cladding, typical of appearance in all parts of sheet. Area is from upper left corner of nugget in figure 31, X100. Keller's etch, 20 seconds. No significant extent of corrosion was observed.

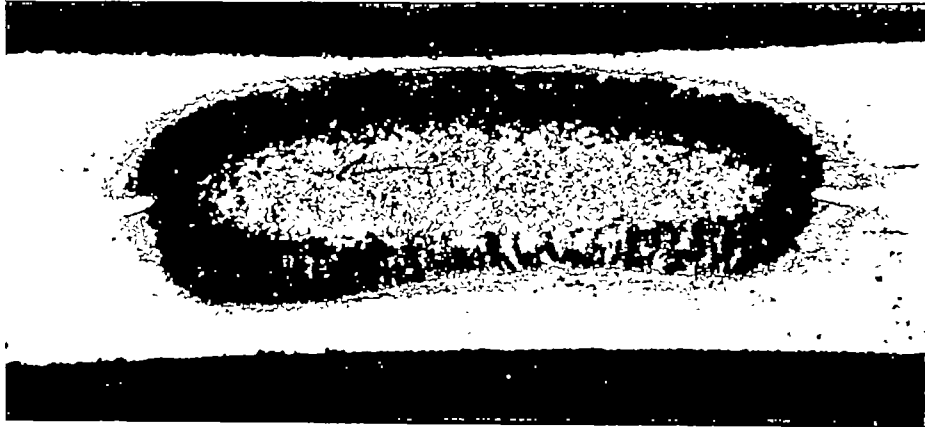
Figure 34.- Macrograph showing weld nugget slightly below clad surface in sample 9F, alclad 24S-T3, welded under conditions to produce a sound weld after wire-brush preparation and exposed 3 years to sea coast atmosphere, X20. Keller's etch, 20 seconds. Compare with figure 31.

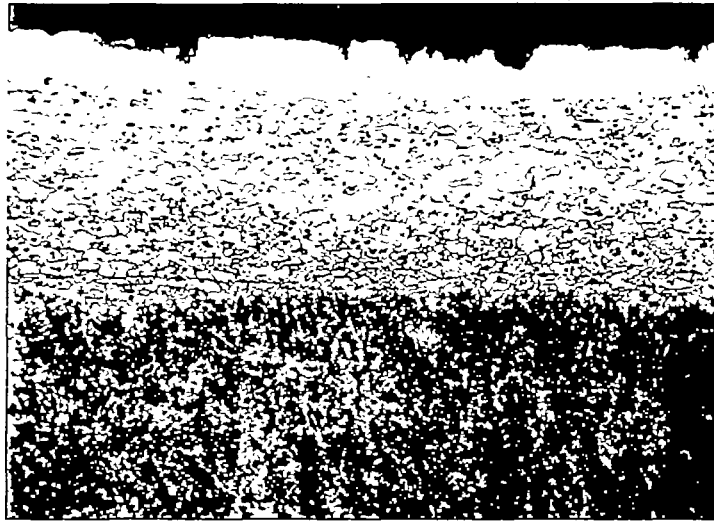
Figure 36.- Extent of surface attack on opposite side of sheet from region in figure 35, X100. Keller's etch, 20 seconds. Attack penetrated over half of cladding thickness, but was not greater in extent than in other parts of sheet surface away from weld.

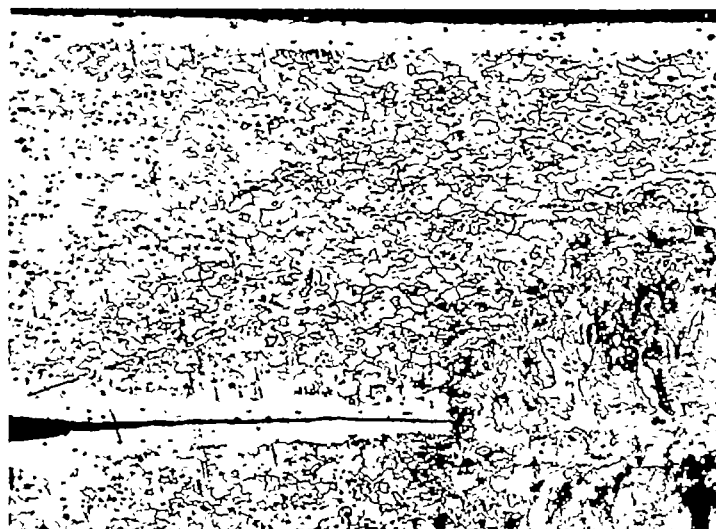
Figure 38.- No significant extent of attack was observed on outer or faying surfaces of sample 2R4. Dark areas in cladding alloy are constituent particles, X100. Keller's etch, 20 seconds.

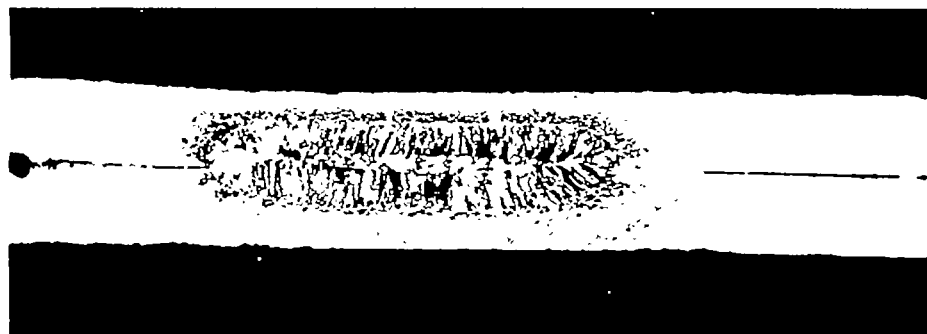
Figure 39.- Macrostructure of sample 2R6, R-301-T6, welded to produce a sound structure after chemical preparation and exposed 3 years to sea coast atmosphere, X20. Keller's etch, 30 seconds.

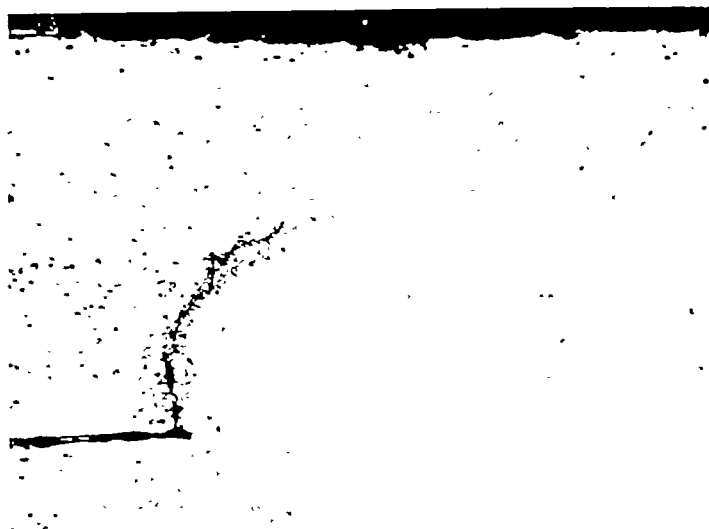
Figure 40.- Typical appearance of envelope of constituent particles segregated along periphery of weld nugget, X100. Unetched. This condition was characteristic of R-301-T6 sheet welds, was observed in XB75S-T6 welds, but not apparent in alclad 24S-T3 welds. Identity of constituents was not established completely but from etching characteristics it was believed that they were of the insoluble aluminum-copper-iron-manganese phase. The crack, possibly formed during specimen preparation, illustrated susceptibility of the condition to propagation of fracture.

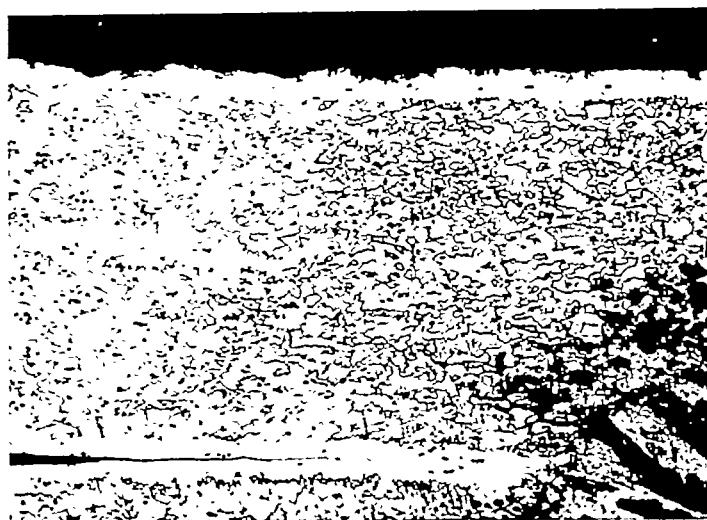
Figure 41.- Example of general type of corrosion observed on outer and inner surfaces of sample 2R6 in all parts of sample, X100. Keller's etch, 30 seconds.

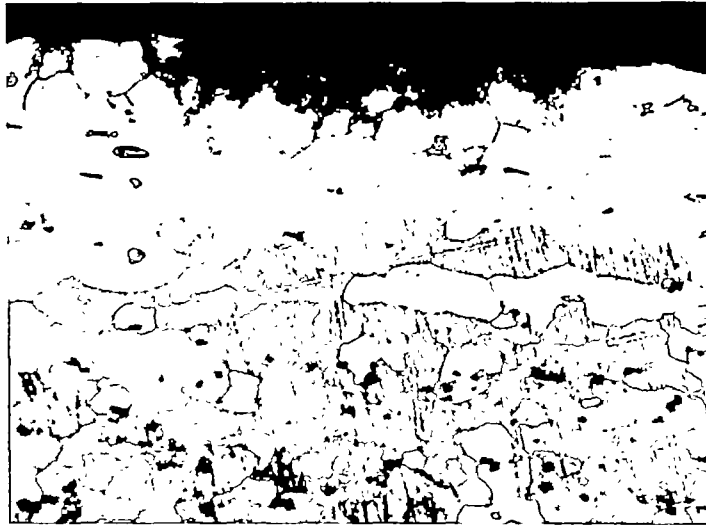
Figure 42.- Example of general type of corrosion observed on outer and inner surfaces of sample 2R6 in all parts of sample, X500. Keller's etch, 30 seconds. Attack appeared to be predominantly intergranular but had not penetrated coating.

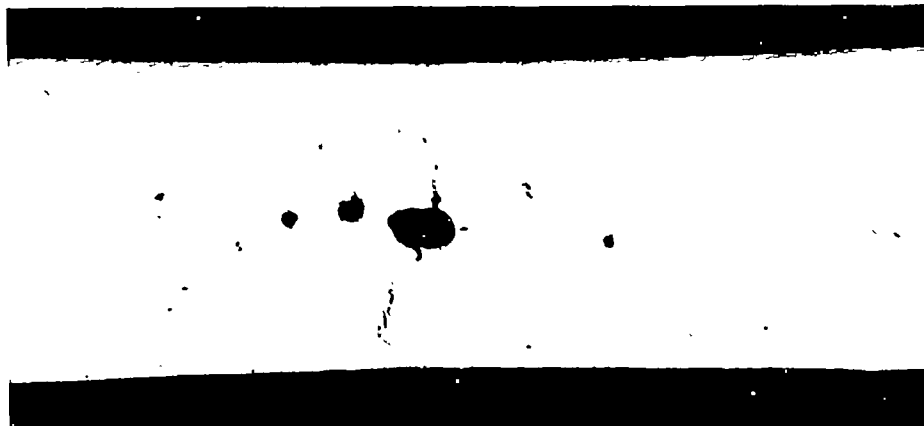
Figure 43.- Cracks to surface and general unsound weld structure of sample X-15, XB75S-T6, welded with dirty electrodes and exposed 3 years to laboratory atmosphere, X20. Unetched.

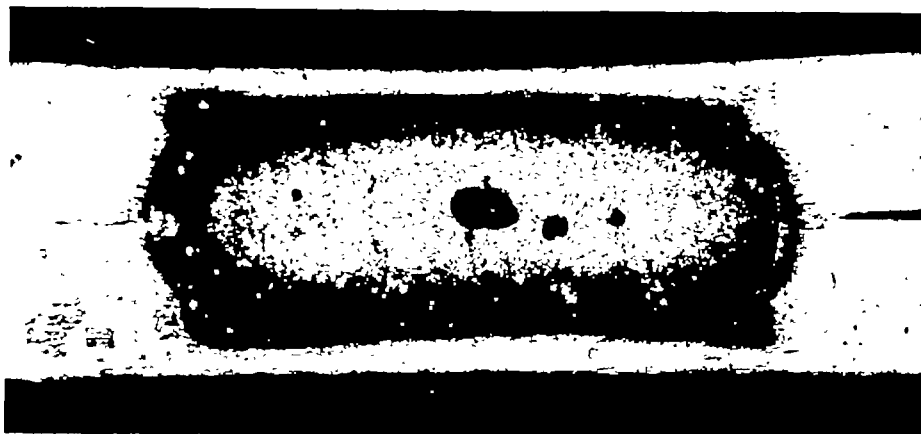
Figure 44.- Etched appearance of sample X-15, X20. Keller's etch, 30 seconds. No distinct evidence of corrosion attack was observed.

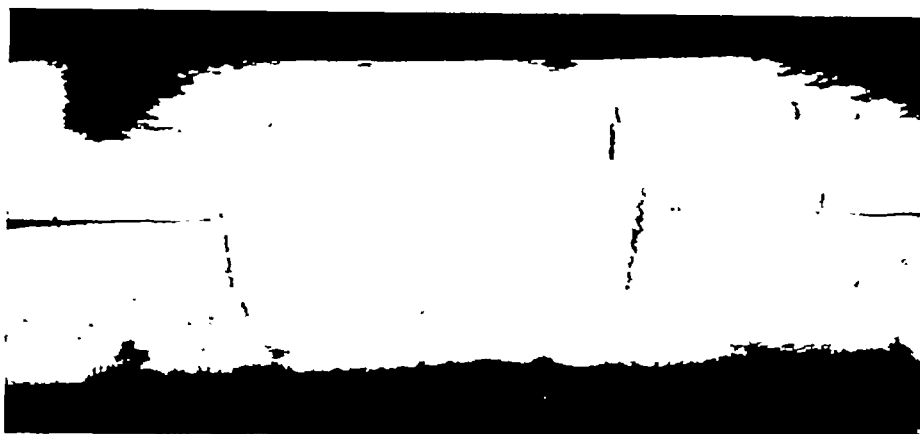
During spot-welding the high temperatures attained and the rapid rates of heating and cooling may have caused some grain-boundary fusion, which possibly was accompanied by local precipitation of some constituent out of solid solution. The corrosion resistance in areas of grain-boundary fusion or in those containing local precipitates of either cathodic or anodic constituents would be impaired under most conditions of exposure.

Figure 45.- Extremely severe intergranular corrosion attack accelerated at periphery of electrode indentation of sample X-9, XB75S-T6, welded with dirty electrodes after chemical preparation of surfaces and exposed 12 days in tidewater, X20. Unetched. Note thin envelope of constituent particles along periphery of nugget, shown more distinctly in figure 47.

(10) Unprotected spot-welded XB75S-T6 is not recommended for use under marine conditions.

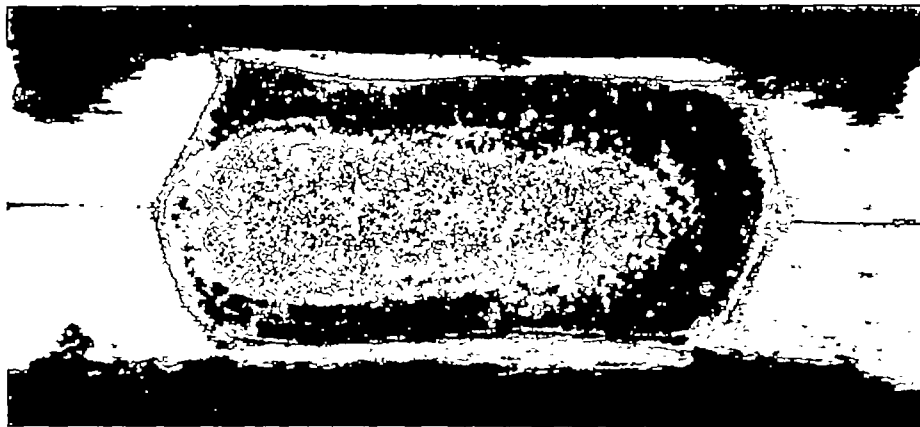
Figure 46.- Etched appearance of sample X-9, X20. Keller's etch, 20 seconds. Note intergranular attack along inner surface at extreme right.

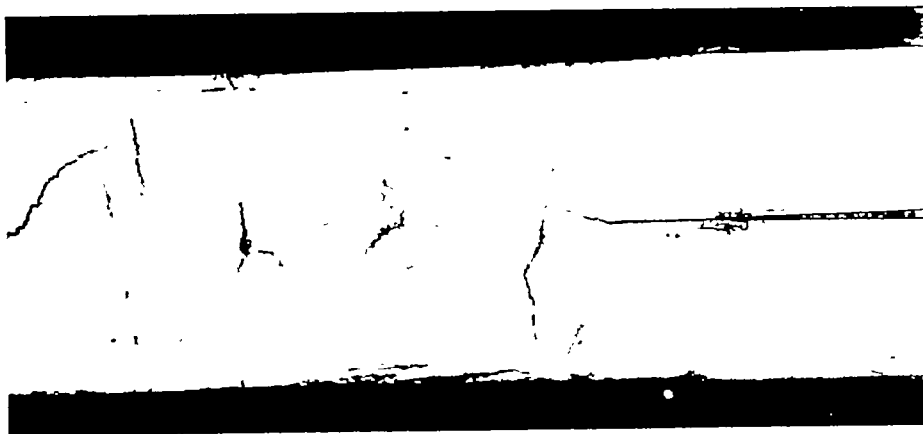
Figure 49.- Severe weld fracturing and intergranular corrosion attack on inner and outer surfaces of sample X-13, XB75S-T6, welded with dirty electrodes and exposed 1 year to sea coast atmosphere, X20. Unetched.

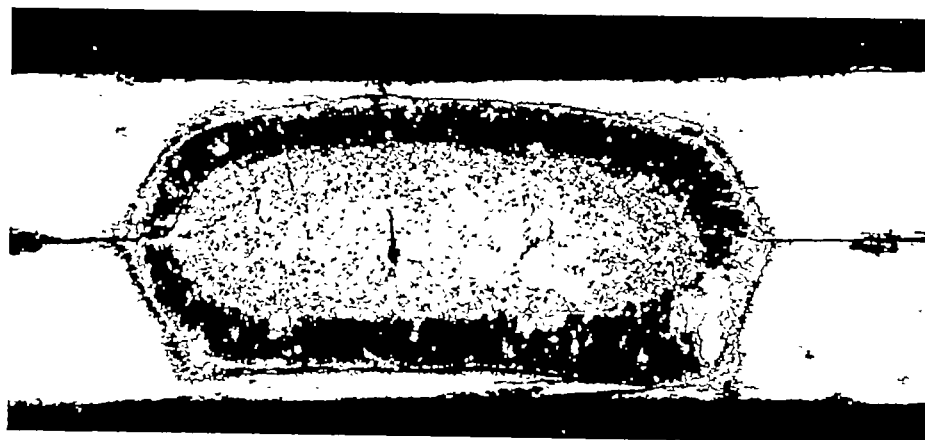
Figure 50.- Etched appearance of macrostructure shown in figure 49, X20. Keller's etch, 30 seconds.
